Effects of Landslide on Environment

By Assoc. Prof. Dr. Alice Sharp & Ms. Sasima Yoocharoen

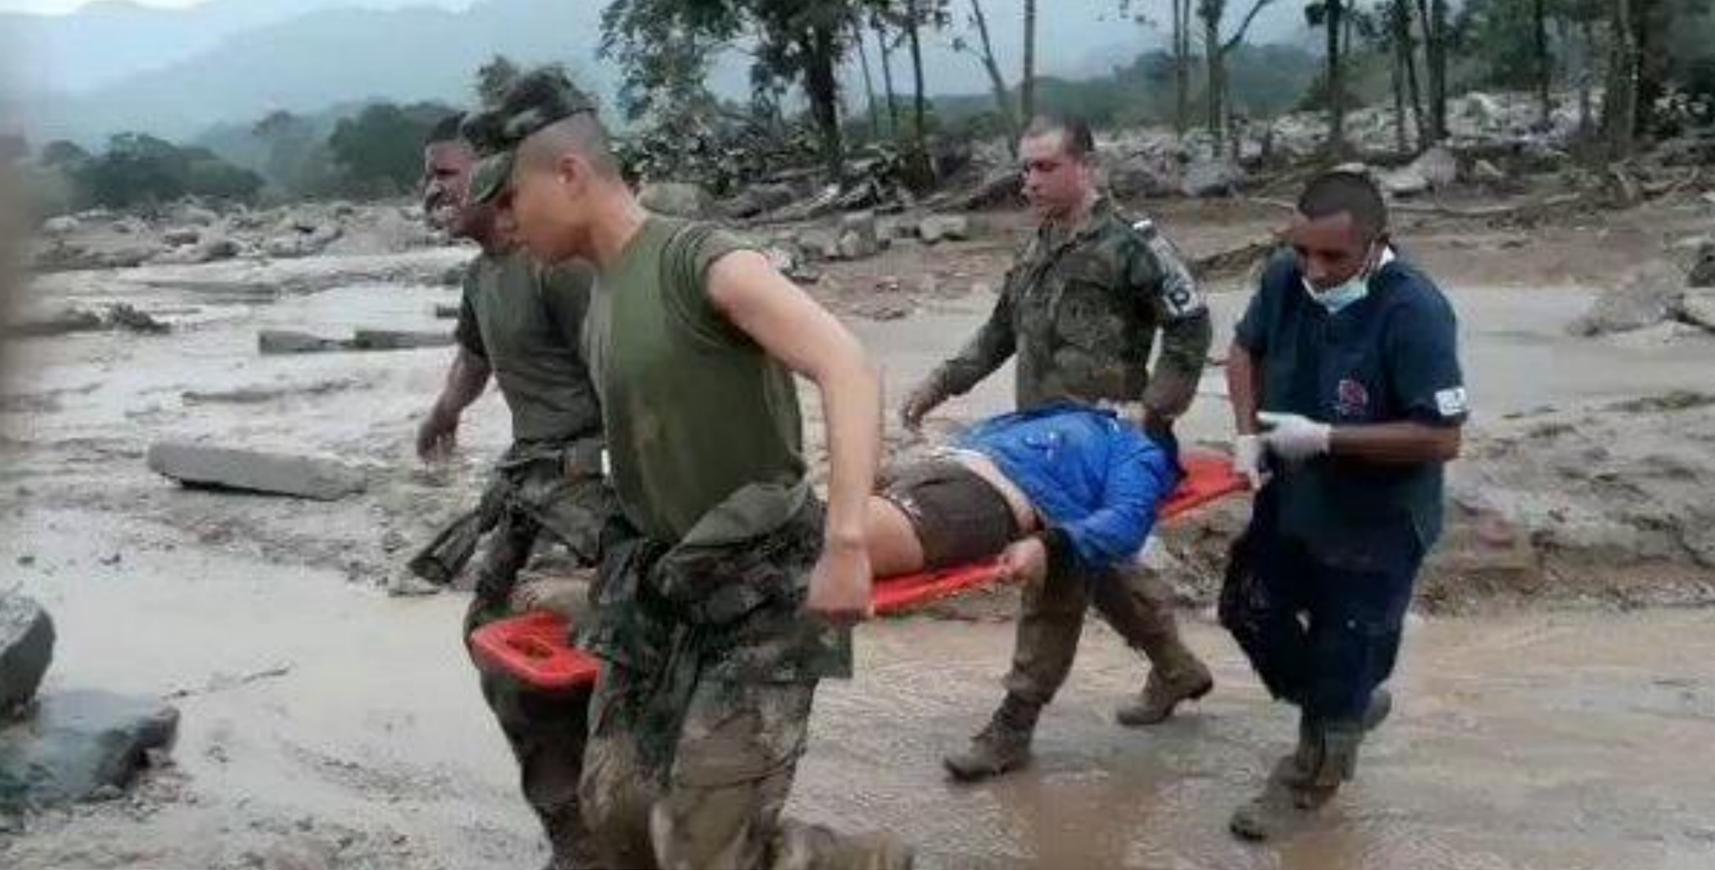
Mudslide in Mocoa, Colombia on Mar 31, 2017

As of 07:00 UTC on April 4, 2017, the number of people that died after massive mudflows hit the Colombian city of Mocoa on Mar 31 has risen to 273. There are over 200 injuries, at least 550 displaced and more than 300 families affected.

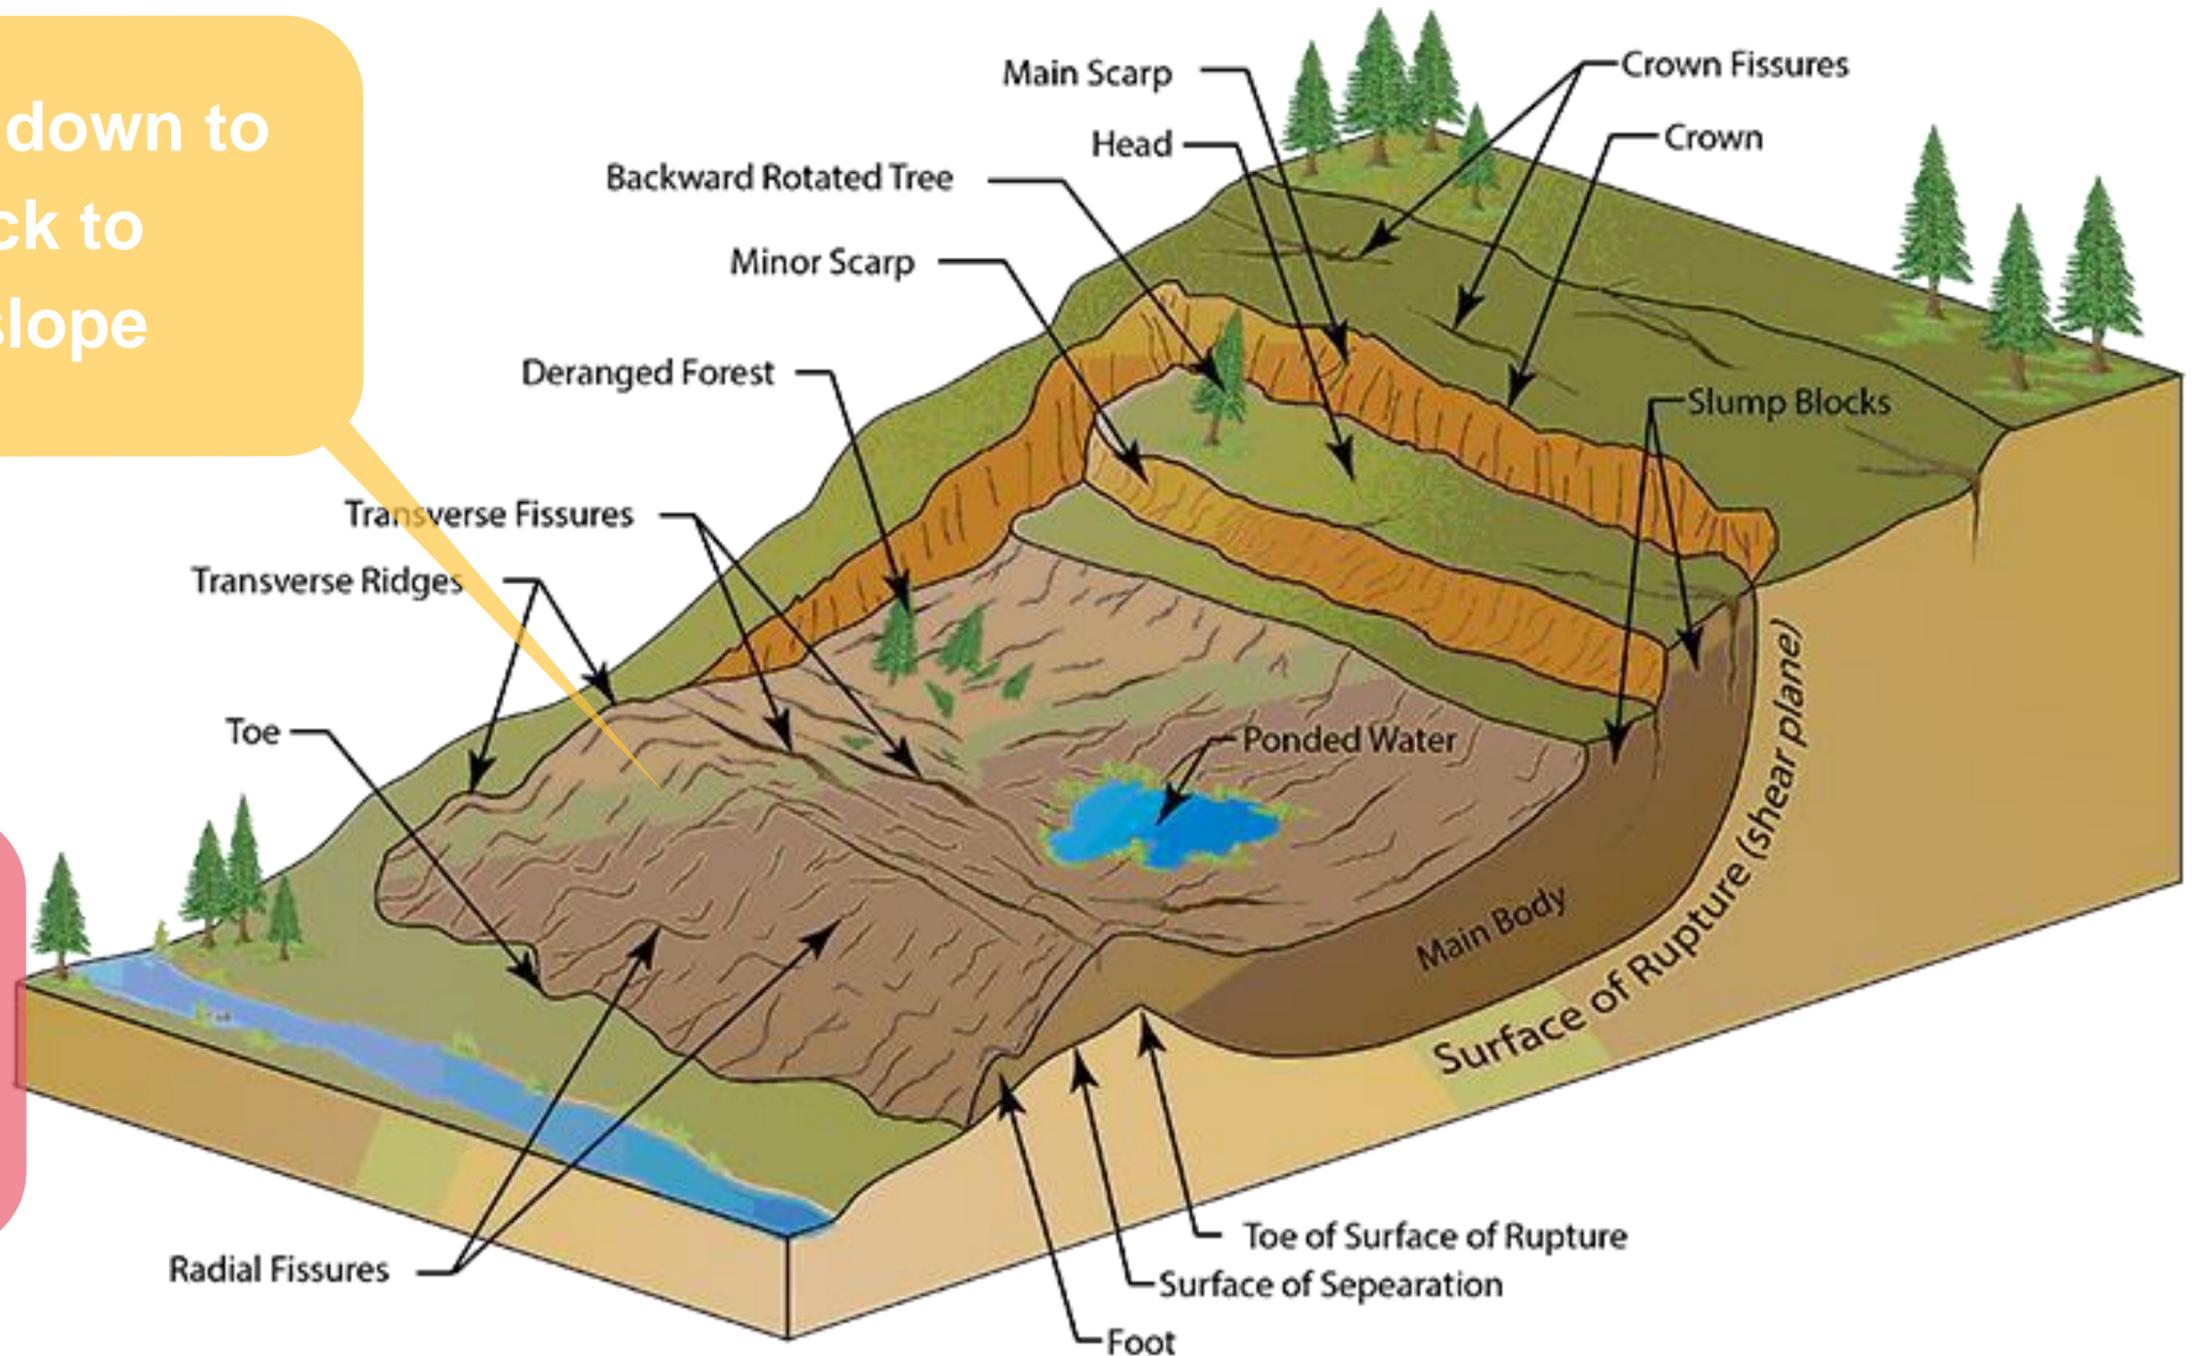
Loss of Soil Resources

Bring soil down to bedrock to downslope

No soil is left for new plants to grow on

The bare tracks of landslides can remain visible for hundreds of years.

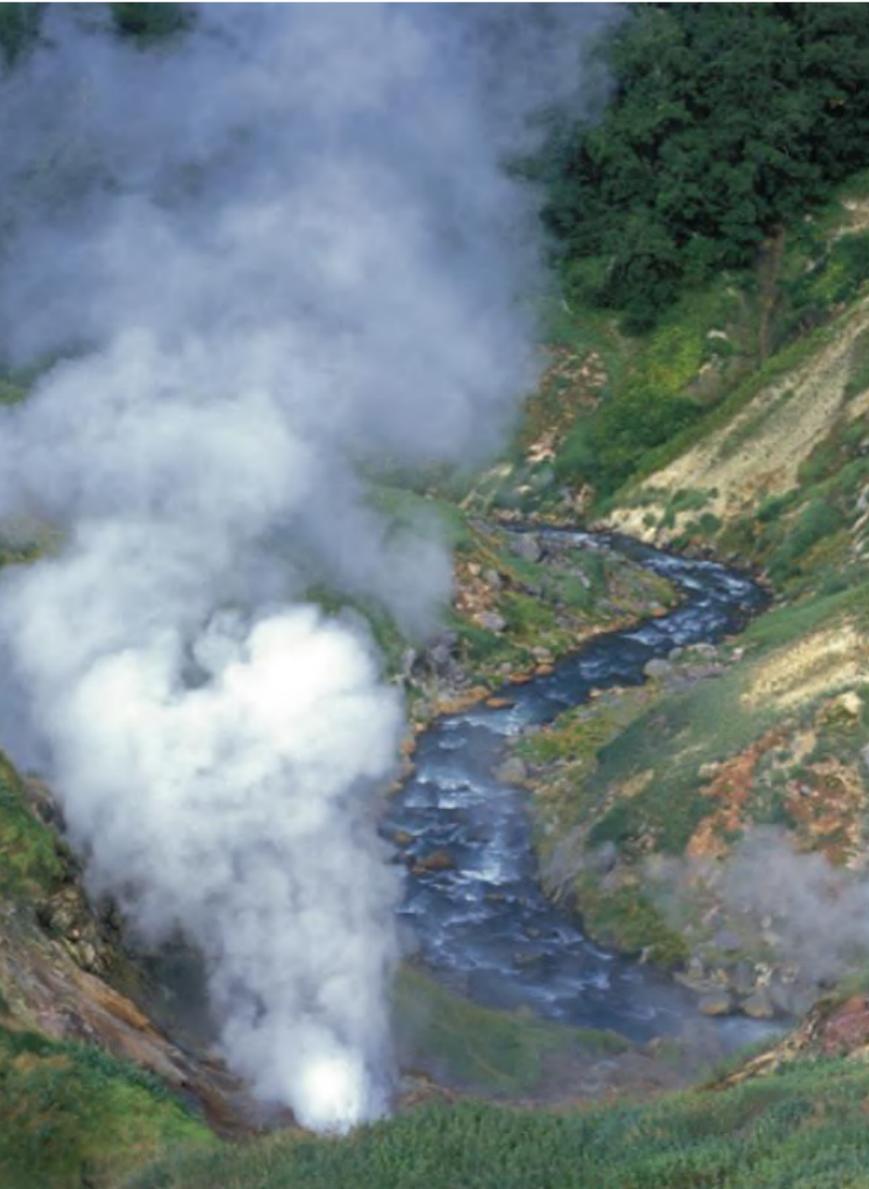
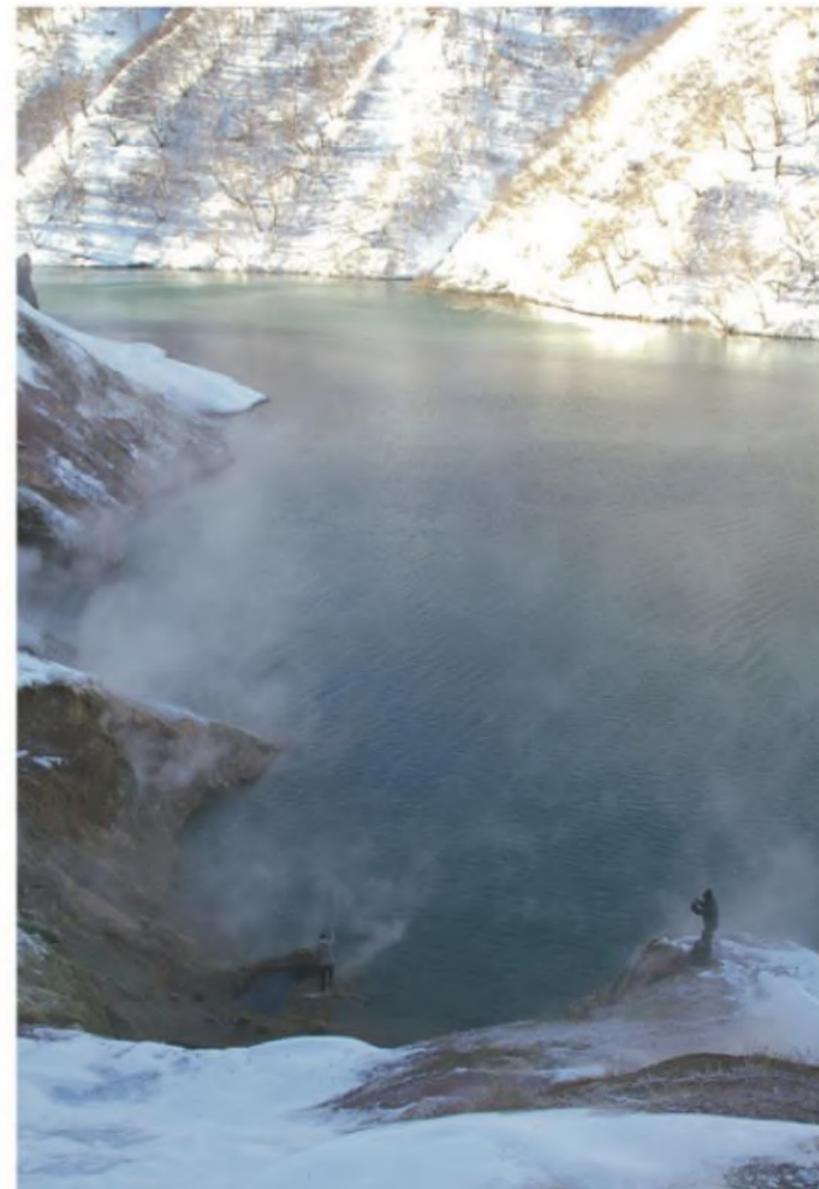
Persist Time

- Several minutes
- Millennia

2 main problems

- Flood valley
- Outburst Flood

Effects from Dams

- Vegetation dies
- Destroy downstream forest and farmland
- Effect with fish and wildlife
- Trigger other landslides

Valley of Geysers before and after the 2007 landslide.

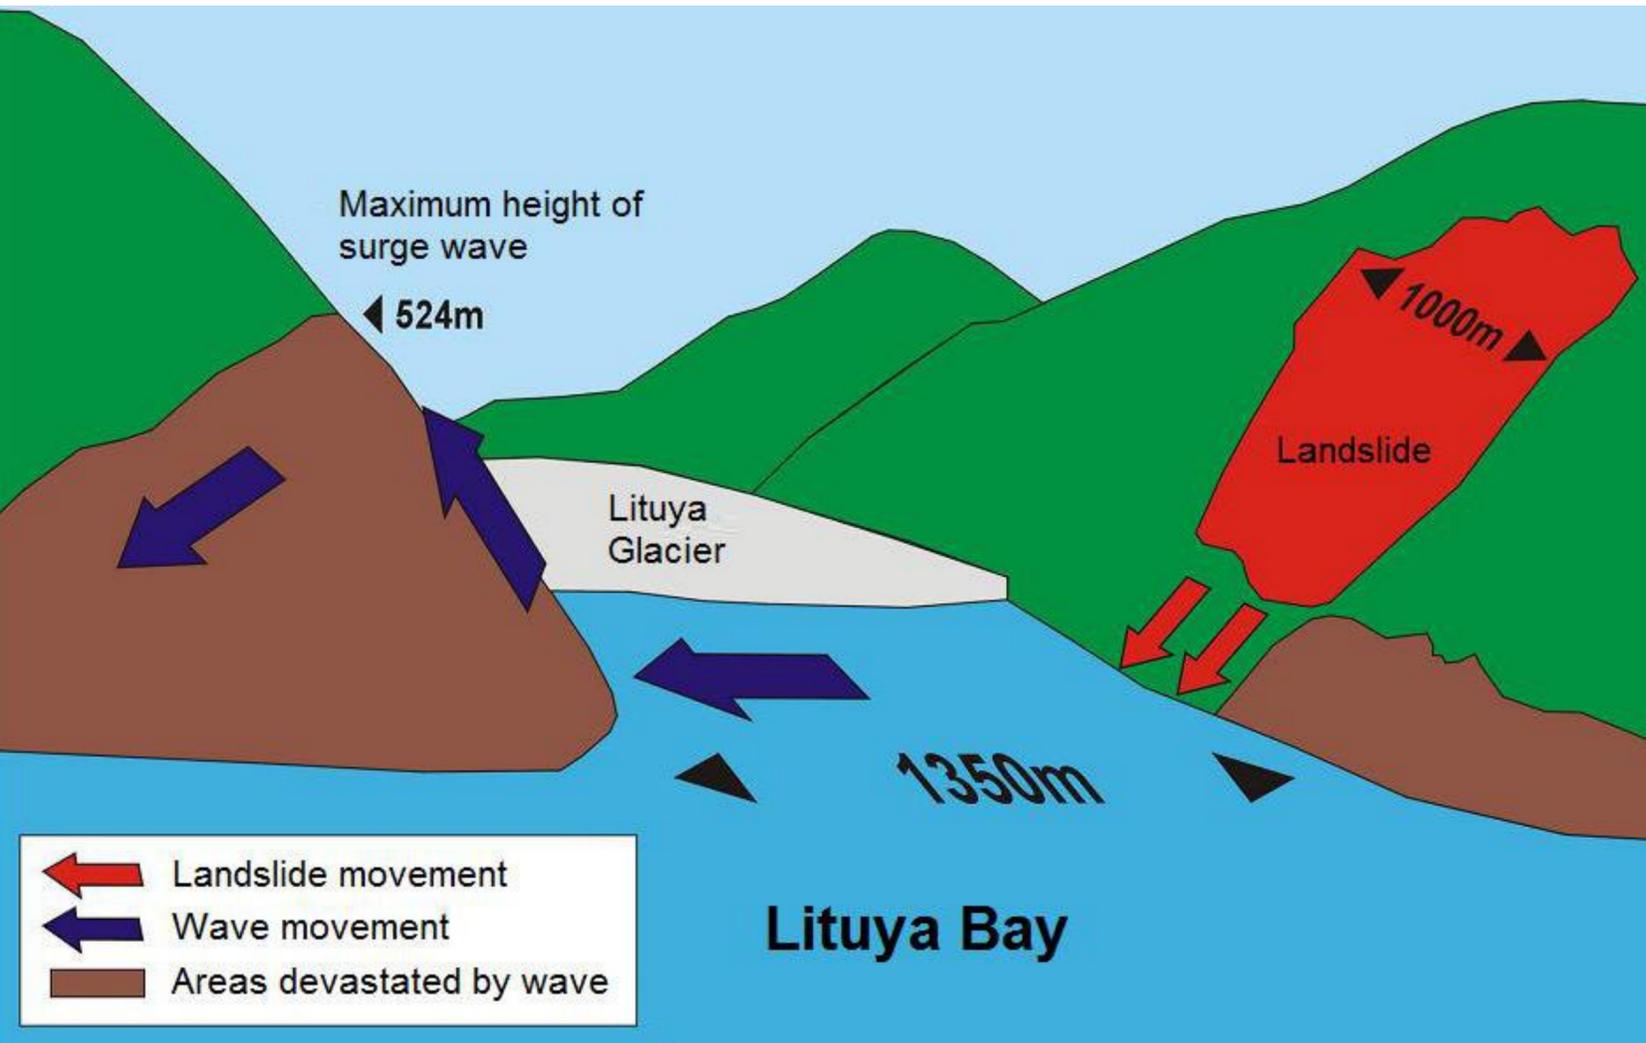
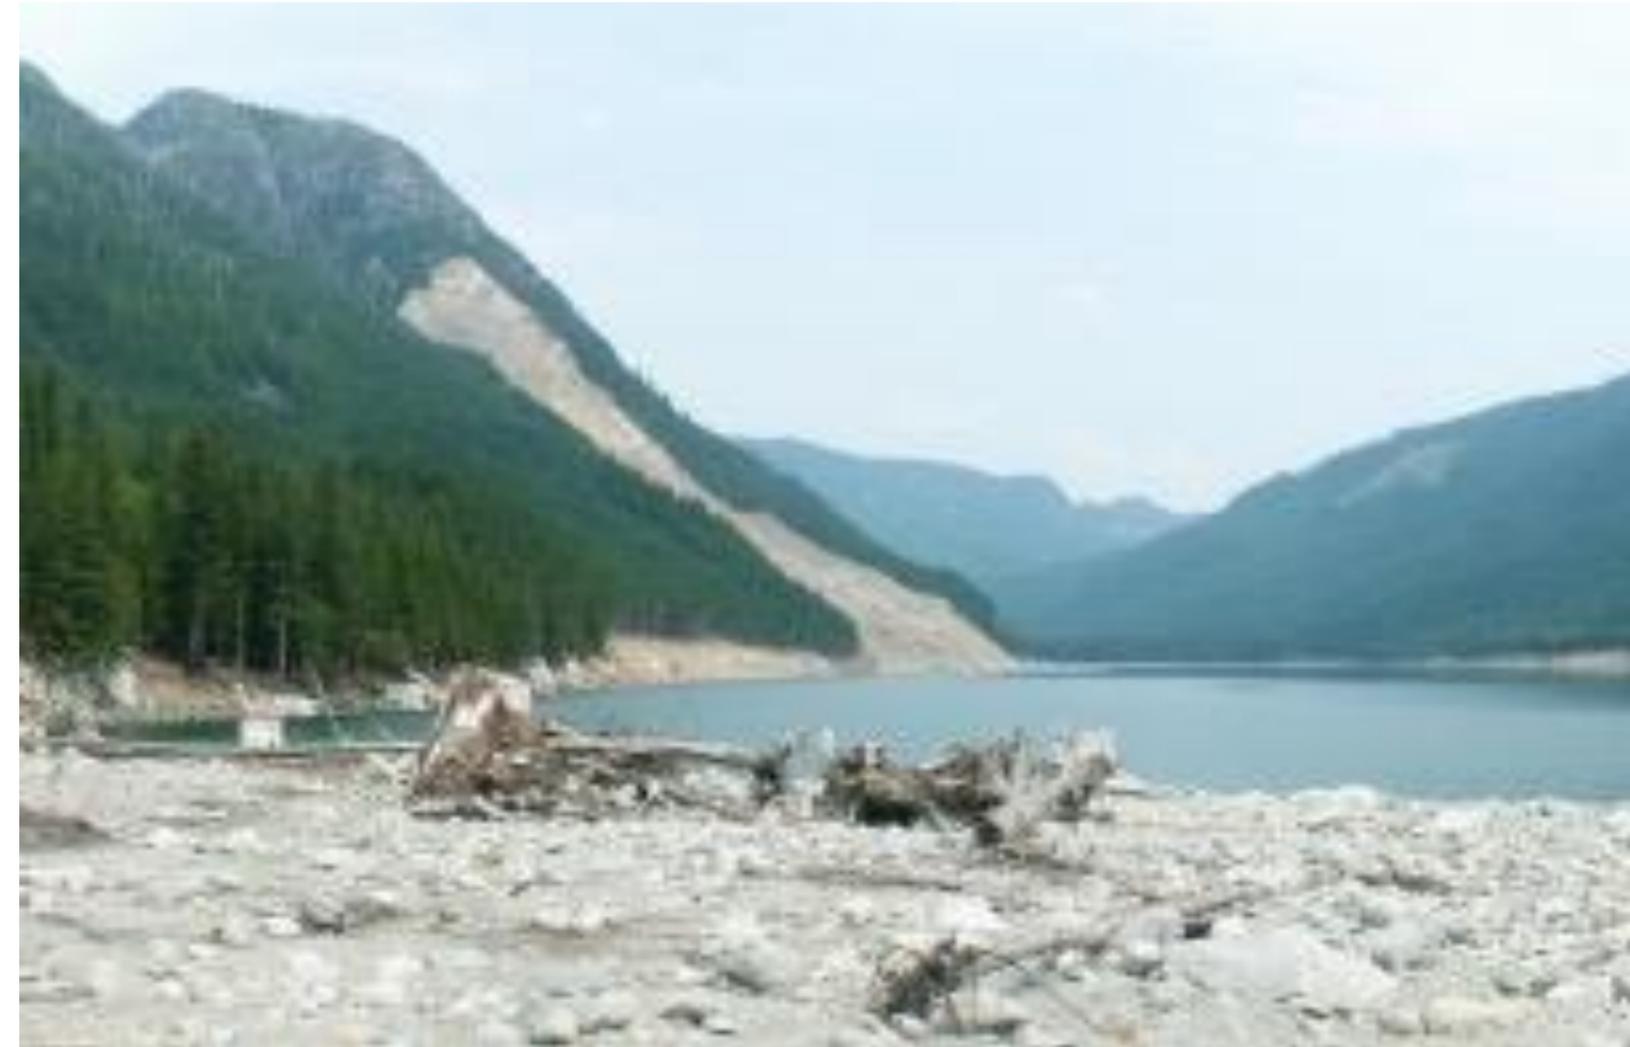
The highest displacement wave in historic time, occurred from a rock slide generated tsunami in Lituya Bay, Alaska in 1958.

Chehalis Lake rock slide and tsunami damage near Vancouver, Canada on December 4, 2007.

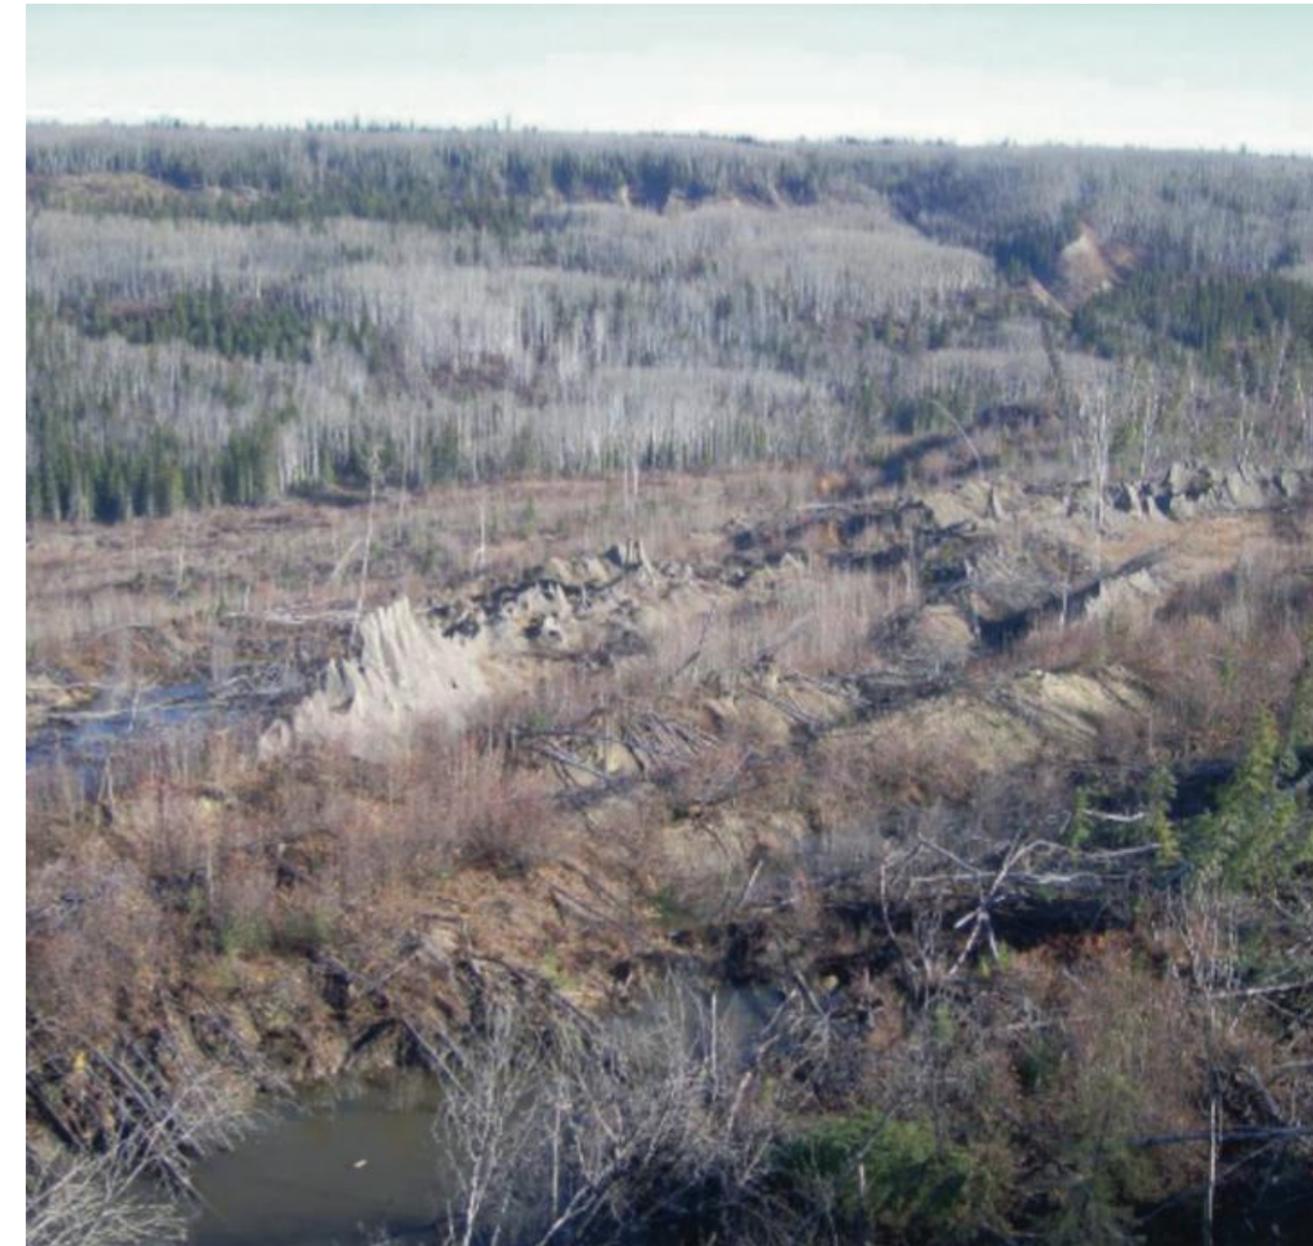
Landslide impacts site is by changing site's topography

Positive

microtopography

Hummocks and ridges rise up from the main ground surface and are often drier and warmer than surrounding terrain.

Negative

Such as sag ponds
