# WARNING SYSTEM IN THE PHILIPPINES FOR SHALLOW TRANSLATIONAL AND DEEP SEATED-LANDSLIDES

Arturo S. Daag, PhD

Philippine Institute of Volcanology and Seismology (PHIVOLCS)

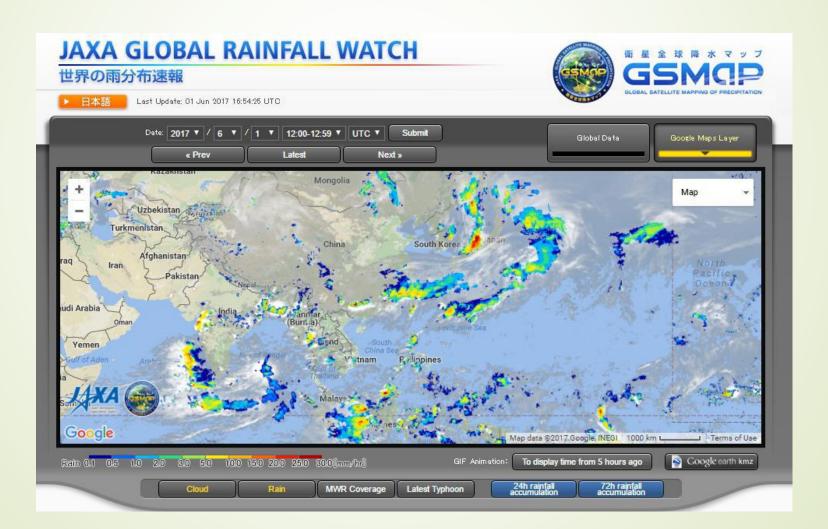
# Global Satellite Mapping OF Precipitation (GSMap)

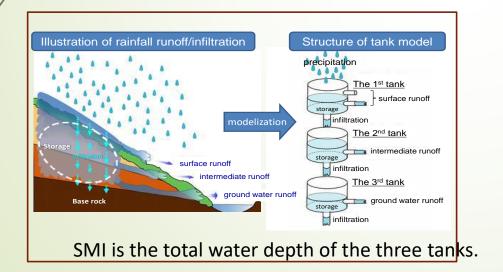
Hourly Rainfall (Locally calibrated GSMaP)

Hourly rainfall (mm/h)

Soil Moisture Index (estimated from tank model)

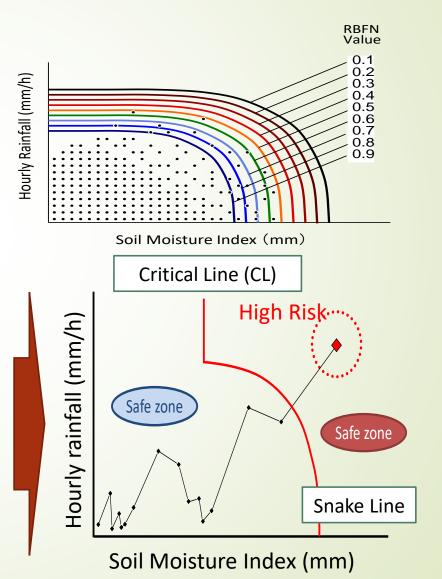
Risk Level based on Critical Lines

GSMaP rainfall archives are analyzed by a machine learning method (RBFN), and critical lines (CLs) of hourly rainfall and soil moisture index (SMI) are selected.

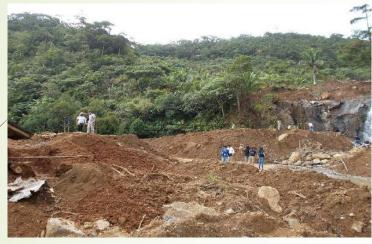
A local calibration and training on the use of WEB-based Landslide Warning System (GLAWS) was conducted in Antipolo City (Barrangay-Level) and Rizal Province (Municipal Level) together with National DRR agencies (MGB,PAGASA,PHIVOLCS).

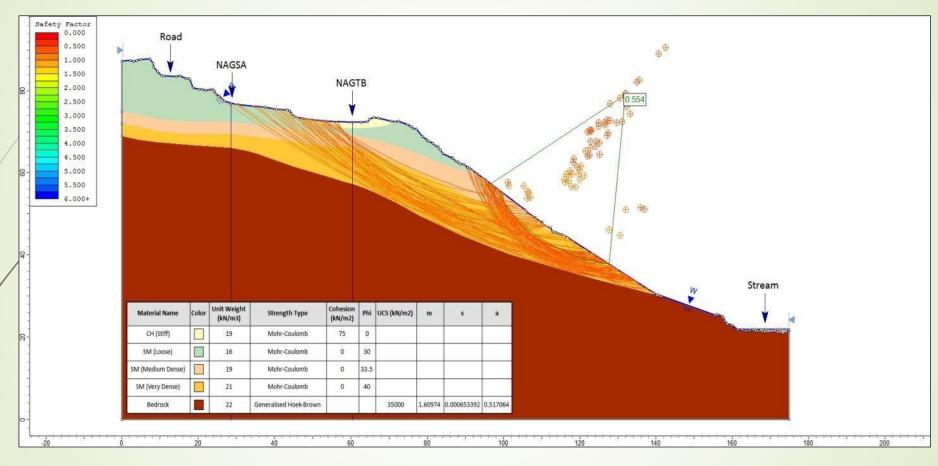
**Nagyubuyuban, San Fernando City, La Union.** Slope stability analysis for the saturated condition showing all surfaces with factors of safety less than 1.0. Factor of safety is 0.554.

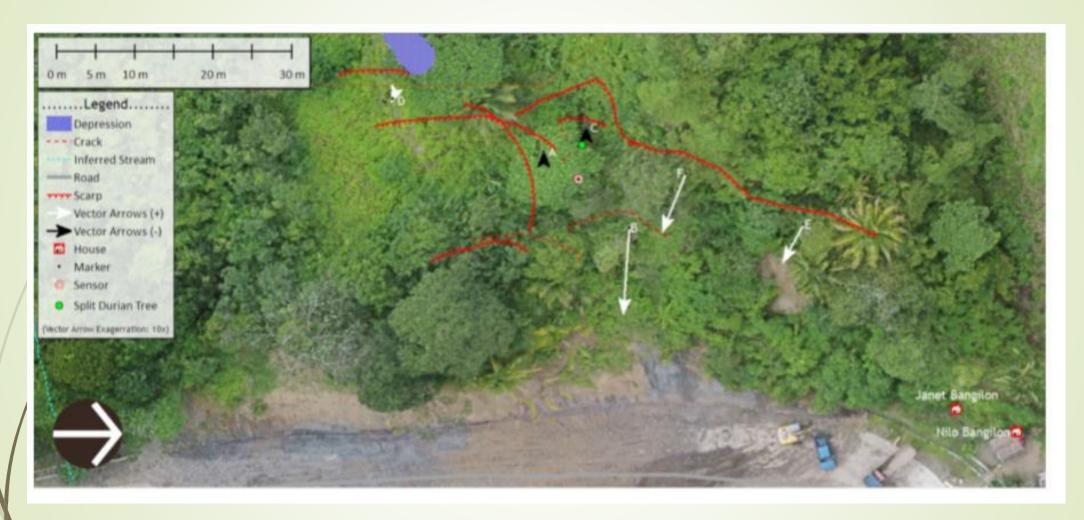
# Mapping of active fissures for monitoring

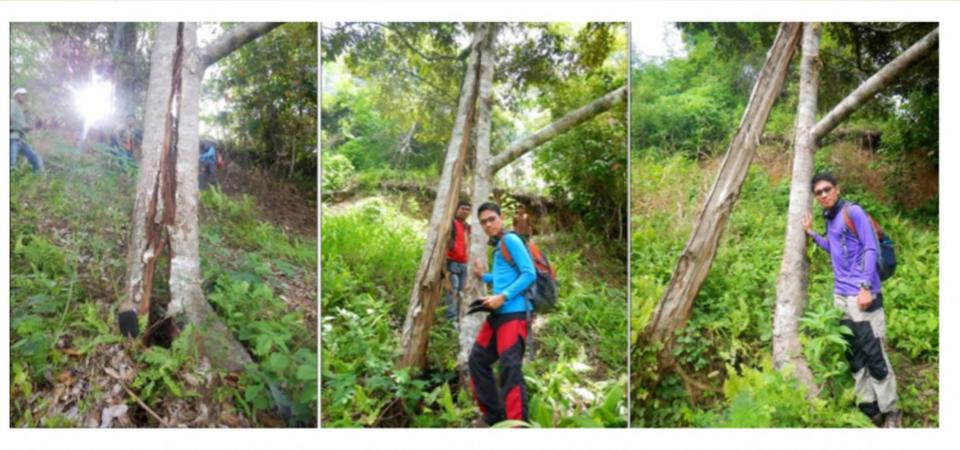
Figure 6.9. Time series photo of tree split by ground displacements at Lower Mesolong, Talaingod. Left to right: June 11, July 28, and November 4, 2015.

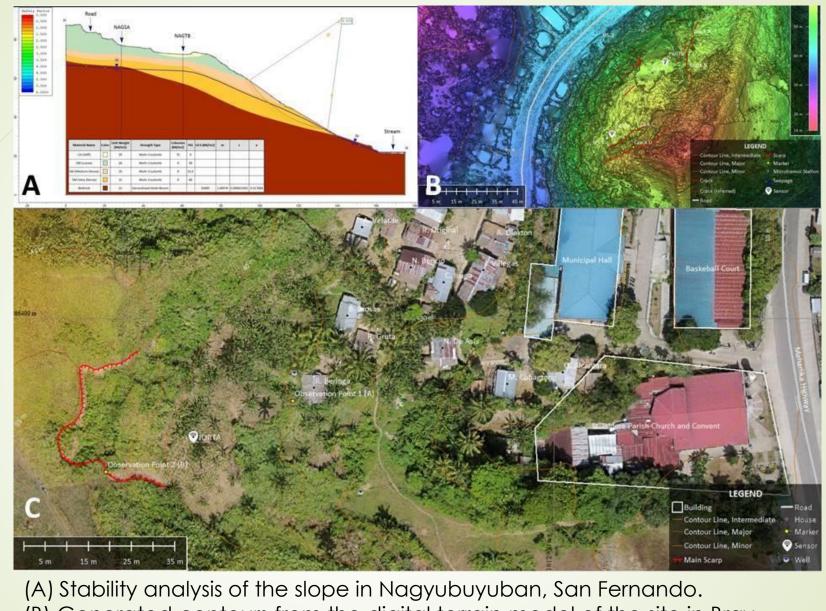
- (B) Generated contours from the digital terrain model of the site in Brgy. Parasanon, Pinabacdao, Samar.
- (C) Features and exposure map of the site in Poblacion 1, San Jorge, Samar

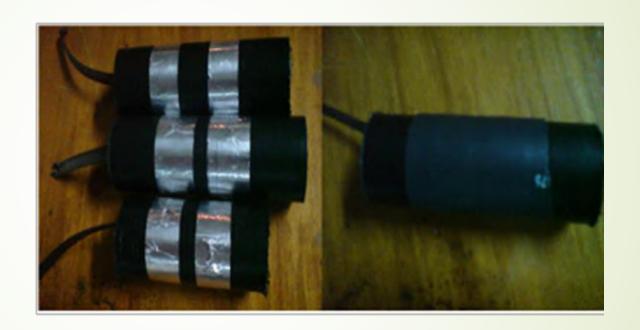
# Manufacturing of Tilt and Moisture Sensor 1 set of sensors per meter

Tilt Sensor

Moisture Sensor

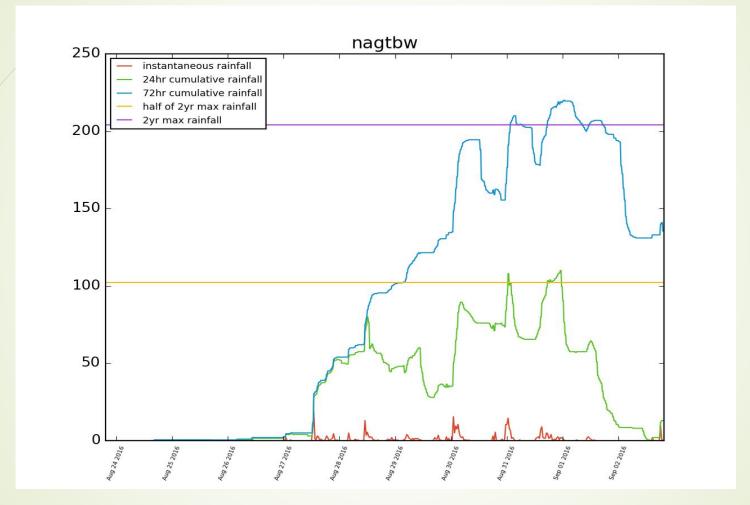
Preliminary thresholds : Rainfall

Plot for evaluating 1- and 3-day cumulative rainfall against their respective thresholds ( $\frac{1}{2}$  of 2 yr max, and 2 yr max)

Early warning protocoligger Sym-Description Threshold bol Operational triggers R0No landslide-triggering 1- and 3-day cumulative rainfall values are below rainfall event detected threshold conditions (see R1, below) R1 Recent rainfall may trigger 1-day cumulative rainfall landslide > 1/2 of 2-year maximum daily rainfall; OR 3-day cumulative rainfall > 2-year maximum daily rainfall No landslide-triggering Earthquake magnitude -E0Earthquake earthquake event detected epicentral distance plots above the critical line of Delgado et al. (2011) E1 Recent earthquake may Earthquake magnitude epicentral distance plots trigger landslide below the critical line of Delgado et al. (2011) On-demand D0No monitoring requests by n/a monitoring LGU and community request D1 Monitoring requested by n/a LGU or community due to rainfall, earthquake or other landslide-related observations LO No significant movement Velocity  $\leq 5^{mm/day}$ Landslide L2 Significant movement Velocity movement > 5mm/day, leg 50cm/dayL3 Critical movement Velocity > 50cm/day

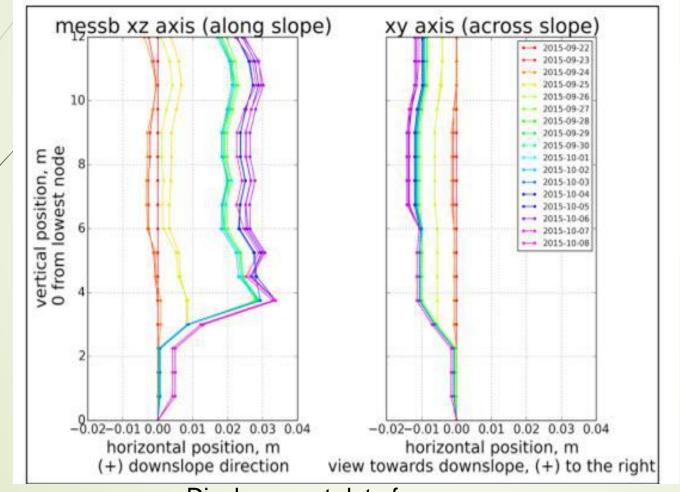
- **Preliminary thresholds:**
- Landslide movement: Tilt data from borehole sensors

Displacement data from sensors

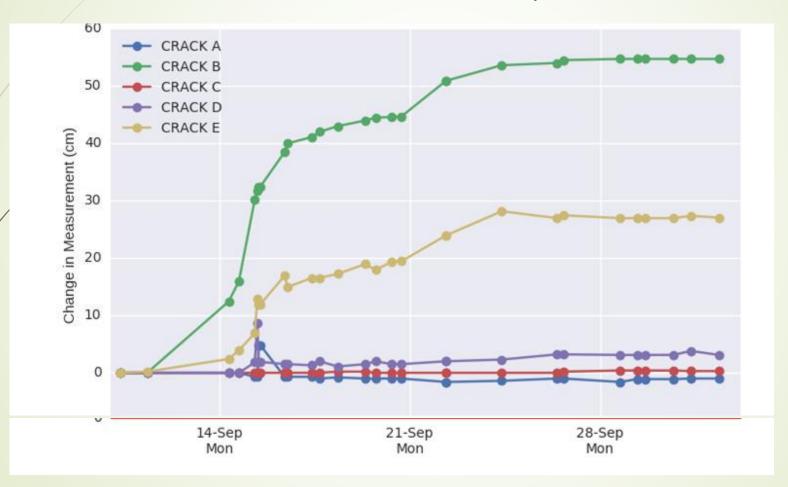
- Preliminary thresholds:
- Landslide movement: Crack displacements at the surface

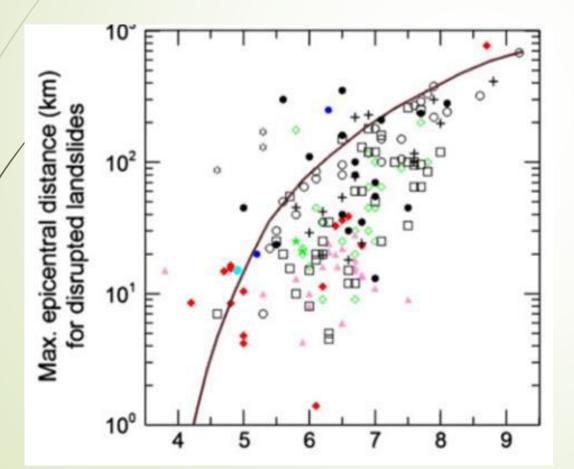
- Earthquake
  - Magnitude, epicentral distance from PHIVOLCS SOEPD

Earthquake-induced landslide threshold as function of earthquake magnitude (x-axis), and epicentral distance (y-axis) for disrupted landslides Delgado et al. (2011)

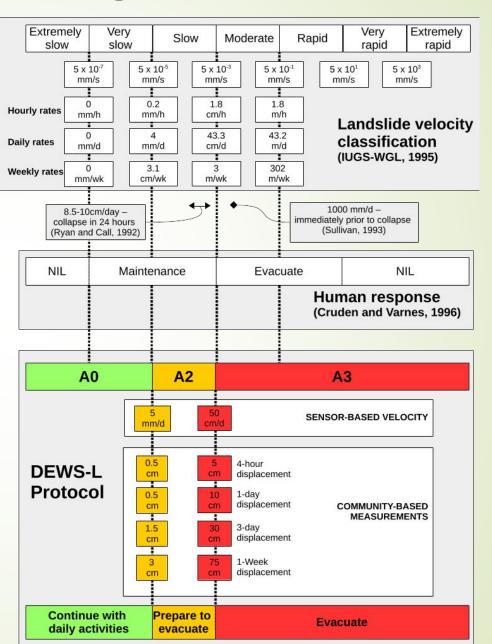
**Preliminary thresholds**

Landslide movement

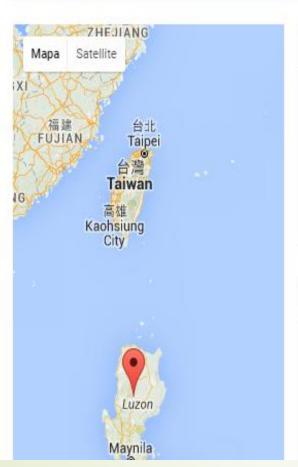
# **DEWS-Landslide Monitoring Dashboard**

Site Name		Initial Trigger Timestamp	Latest Re-trigger	Internal Alert	11
Name 4		rimestamp 11	Timestamp ↓†	Aleit	-41
Cudog		16 July 2016	17 July 2016	A1-R	
		23:30:00	19:30:00		
	-	ed Monitoring End of Prev	ious Alert Validity   †		Monitoring Sta
es Under 3-E Site Name	ay Extende	=	ious Alert Validity ↓†		Monitoring Sta
